Manhole Inspection Summary

Manhole # S53A__012MH

Insp Date: **9/10/08 9:55 AM**

Location Address: **425 n clinton st**

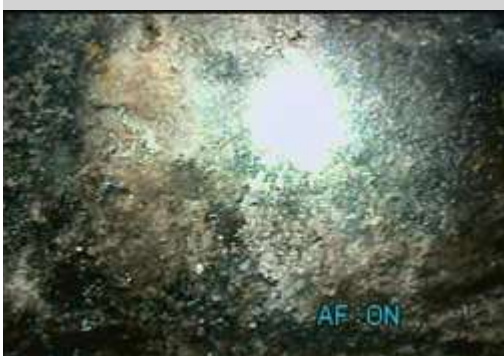
Defect 5

Infiltration: ☐ None ☐ Joint ☐ Cracks ☐ Mortar ☐ Roots ☒ **Wall**

infiltration

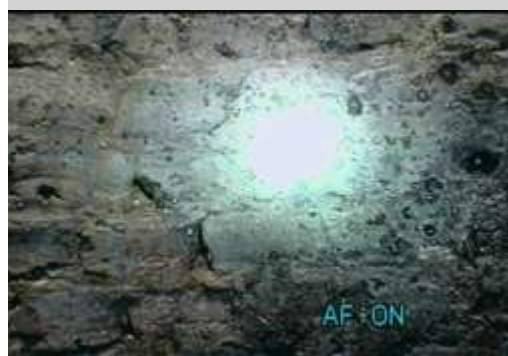
Defect 4

Condition: ☐ Sound ☐ Cracked ☐ Root Intrusion ☐ Loose Brick ☒ **Deteriorated**

barrel

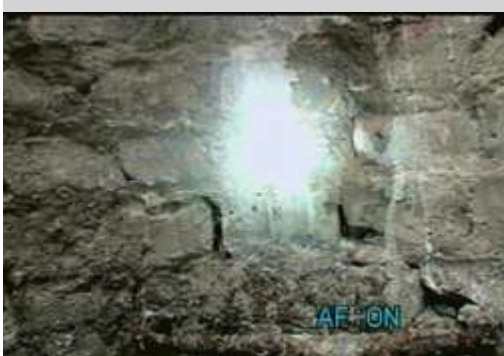
Defect 3

Condition: ☐ Sound ☒ **Cracked** ☐ Root Intrusion ☐ Loose Brick ☒ **Deteriorated**

cracked corbal

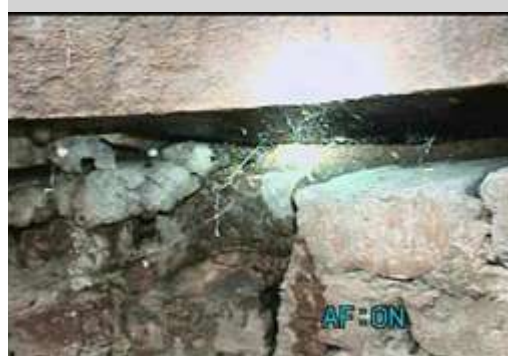
Defect 2

Condition: ☐ Sound ☒ **Cracked** ☐ Root Intrusion ☒ **Loose Brick** ☒ **Deteriorated**

frame adj

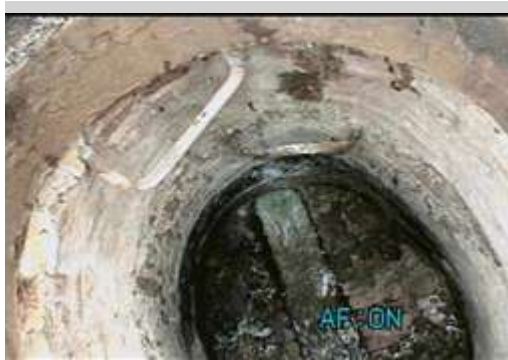
Defect 1

Steps Count: **3** Missing: **2** ☒ **Corroded**

steps

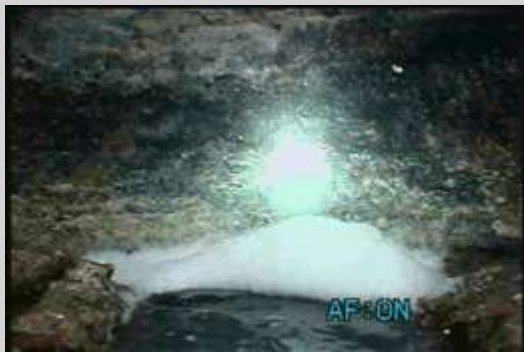
12 O'Clock Outflow

Pipe Material: **Clay** ☐ Pipe Lined

Invert Depth: **6.83** (ft.) Flow Characteristics: **Fast**

Infiltration: **None** Pipe Seal Cond: **Unknown**

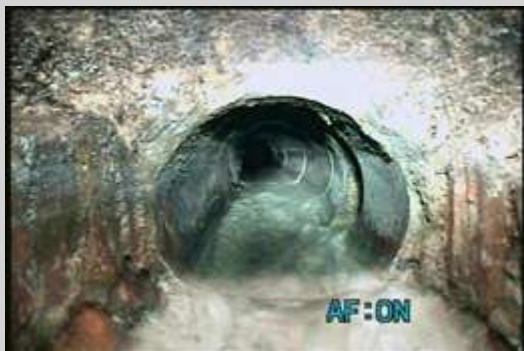
6 O'Clock Inflow

Pipe Material: **Clay** ☐ Pipe Lined

Invert Depth: **6.41** (ft.) Flow Characteristics: **Fast**

Infiltration: **None** Pipe Seal Cond: **Unknown**
